Holiday Inn Birmingham - Walsall M6, J10 - Events and Conference Centre

Guide Last Updated: 17/10/2017

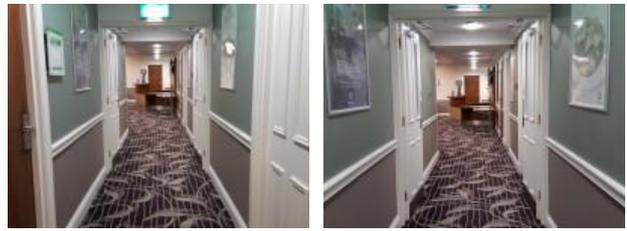
Entrance (Events and Conference Centre Internal Hotel Entrance)

- The entrance area/door is not clearly signed.
- There is step free access at this entrance.
- The entrance door(s) does/do contrast visually with its immediate surroundings.
- The main door(s) open(s) away from you (push).
- The door(s) is/are double width.
- The door(s) is/are heavy.
- The width of the door opening is 126cm.

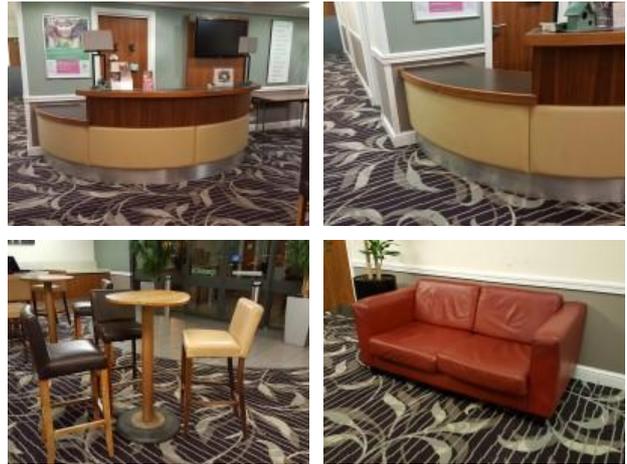
Reception (Events and Conference Centre)

- The reception point is located ahead as you enter via the events and conference centre entrance.
- The reception point is approximately 5m (5yd 1ft) from the events and conference centre entrance.

- The reception area/desk is clearly visible from the entrance.
- There is step free access to the reception point.
- There is a clear unobstructed route to the reception point.

- The lighting levels at the reception point are good.
- The height of the reception counter is high (110cm+).
- There is sufficient space to write or sign documents on the counter.

- There is a lowered section of the counter.
- The lowered section of the counter is not at the recommended height of 76cm.
- There is sufficient space to write or sign documents on the lowered section of the counter.

- There is not a clear knee recess beneath the lowered section of the counter.
- The counter is staffed.
- Clipboards can be provided to anyone who is unable to use the desk.
